# LOSS AND DAMAGE IN THE HIGH MOUNTAINS OF THE EVEREST REGION

Realities, Pains, and Perils from  
Thame Village

Digo Bikas Institute, November 2024

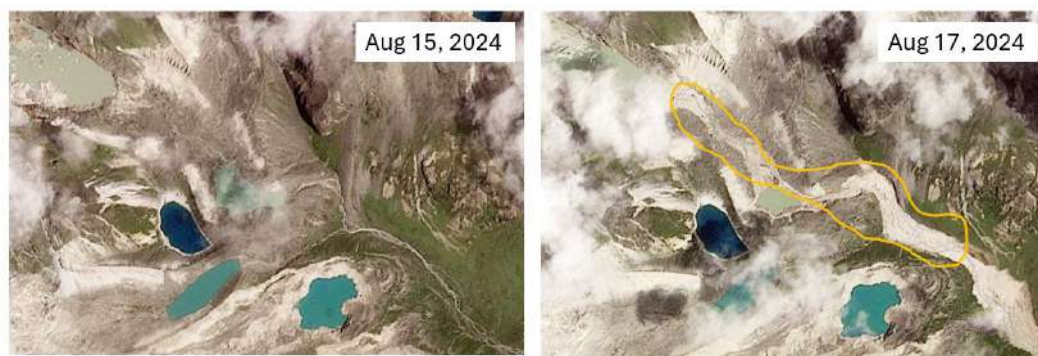
The outburst originated from the Thyanbo glacial lake, which is close to three associated glacial lakes in the upstream region of the Thame village (figure 1). In a press note released by ICIMOD, the size of the glacier lake, four to five hours before the burst, was estimated to be 0.05 square kilometers (ICIMOD, 2024). A comparison of before and after images of the glacial lakes reveals significant changes in its size (figure 1). The most notable differences are observed in the lake in the northern part on the top, which changed in size with a decrease in water accumulation (after the GLOF). This indicates that the GLOF originated from these lakes, causing their water levels to drop drastically as the large volume of water was released, accelerating erosion and deposition of sediments downstream, as evident in Figure 2.

**Figure 1:** Satellite imagery of glacial lake areas before and after, highlighting the origin of the GLOF (Source: Planet Lab)

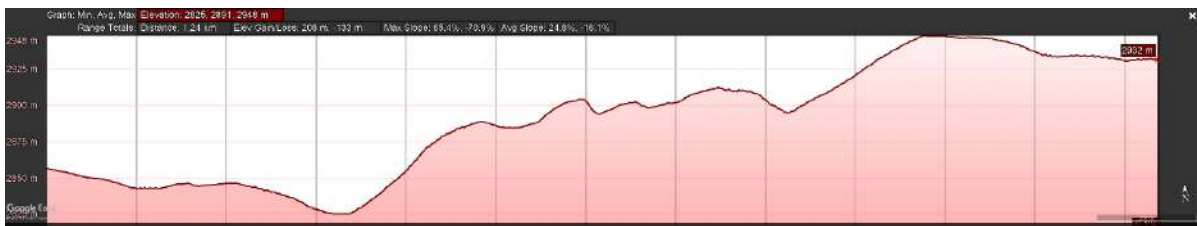
**Figure 17** (a) Change of trail route to Hillary Bridge (green line denotes new trail route and red line denotes previous trail route) (b) Changes in elevation profile due to changes in route

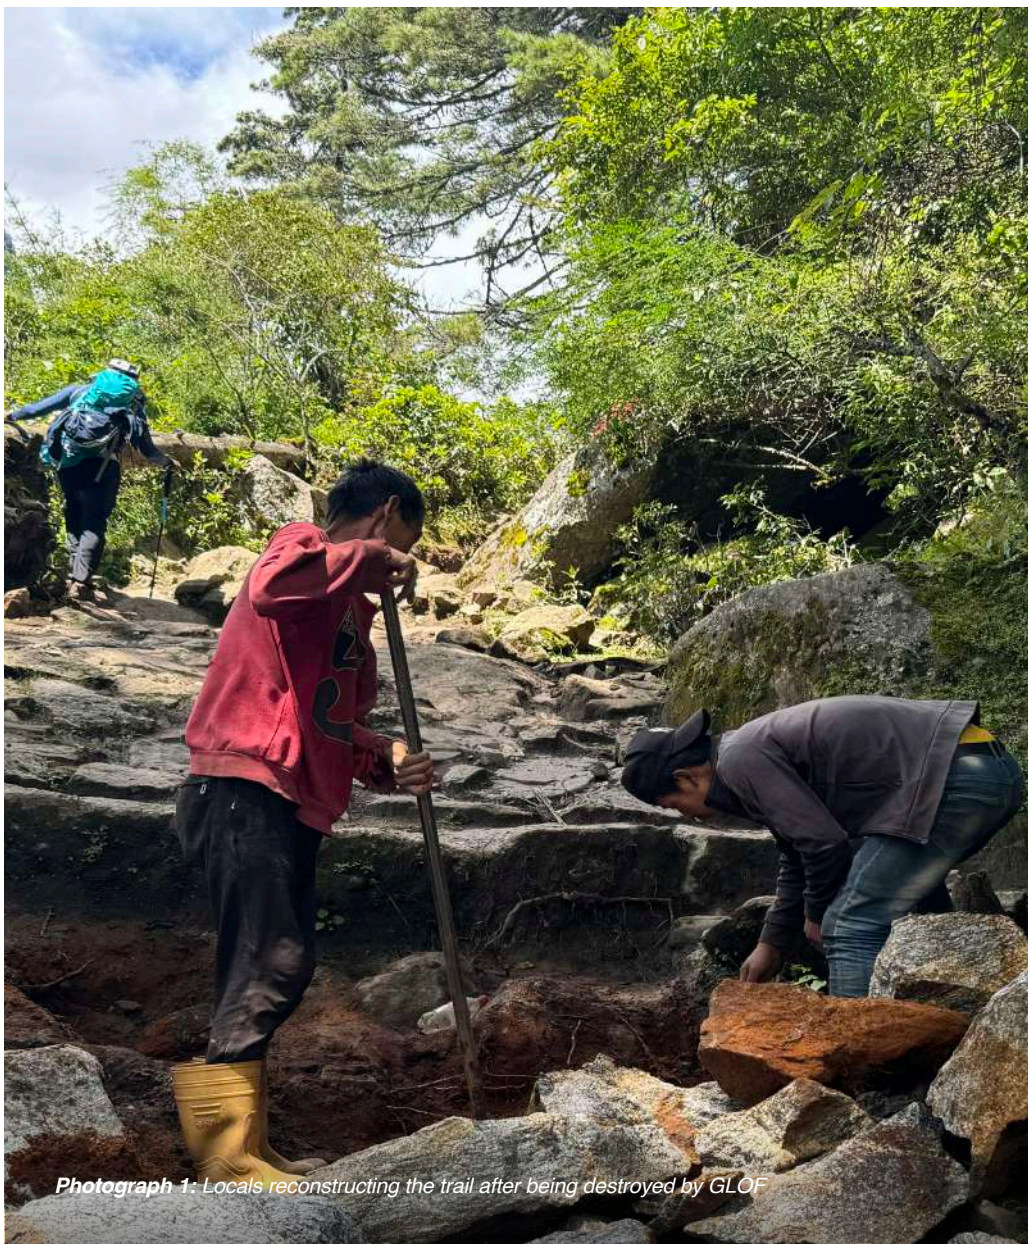
*Photograph 1: Locals reconstructing the trail after being destroyed by GLOF*

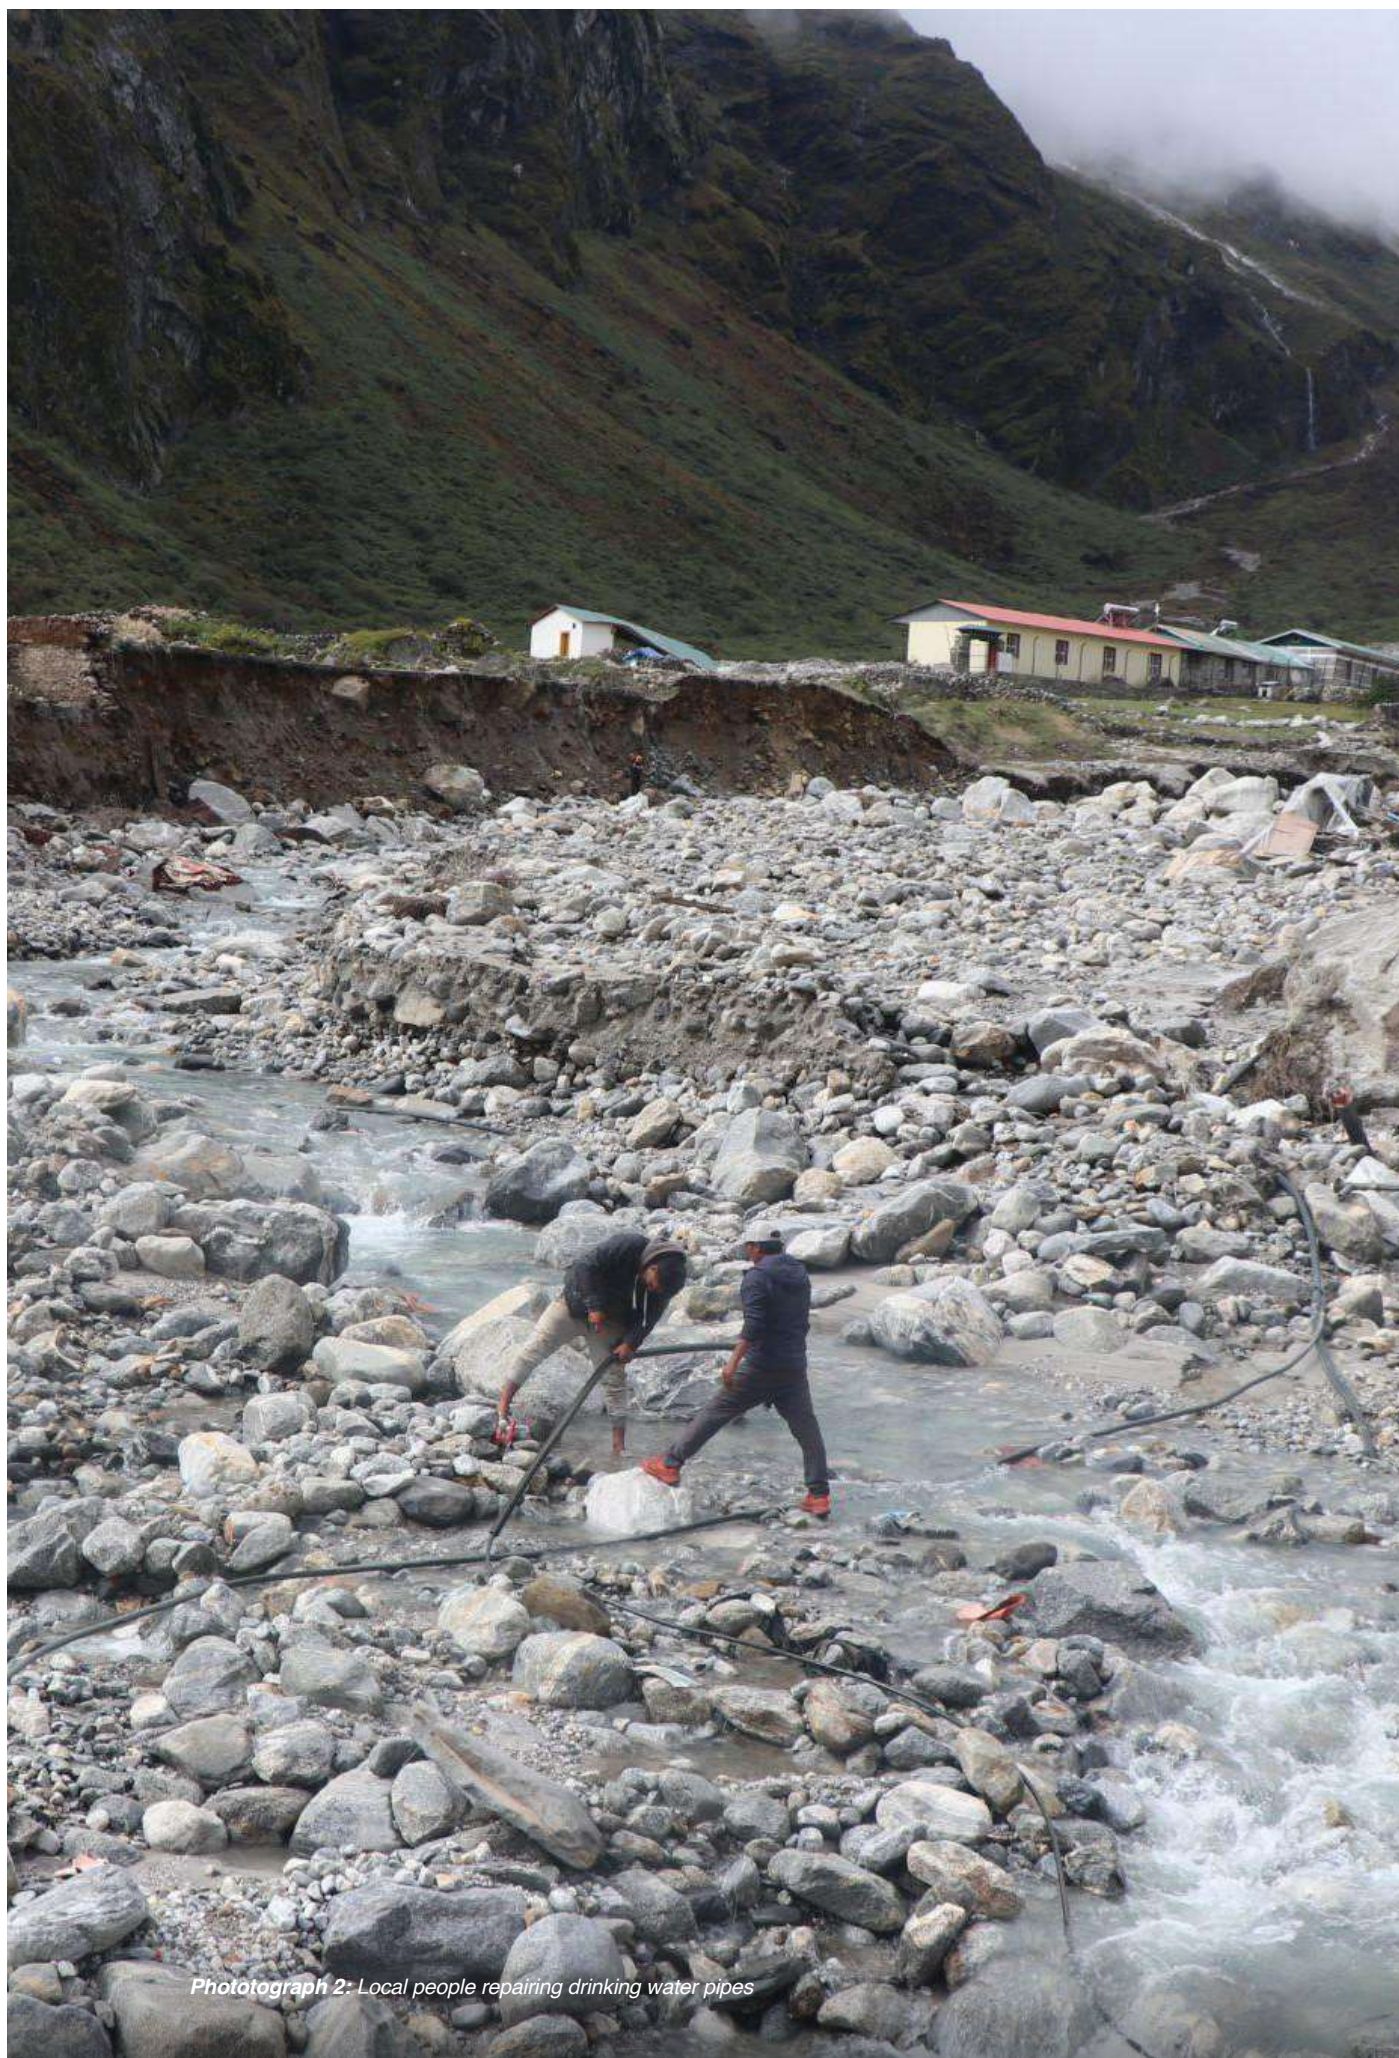
*Photograph 2: Local people repairing drinking water pipes*

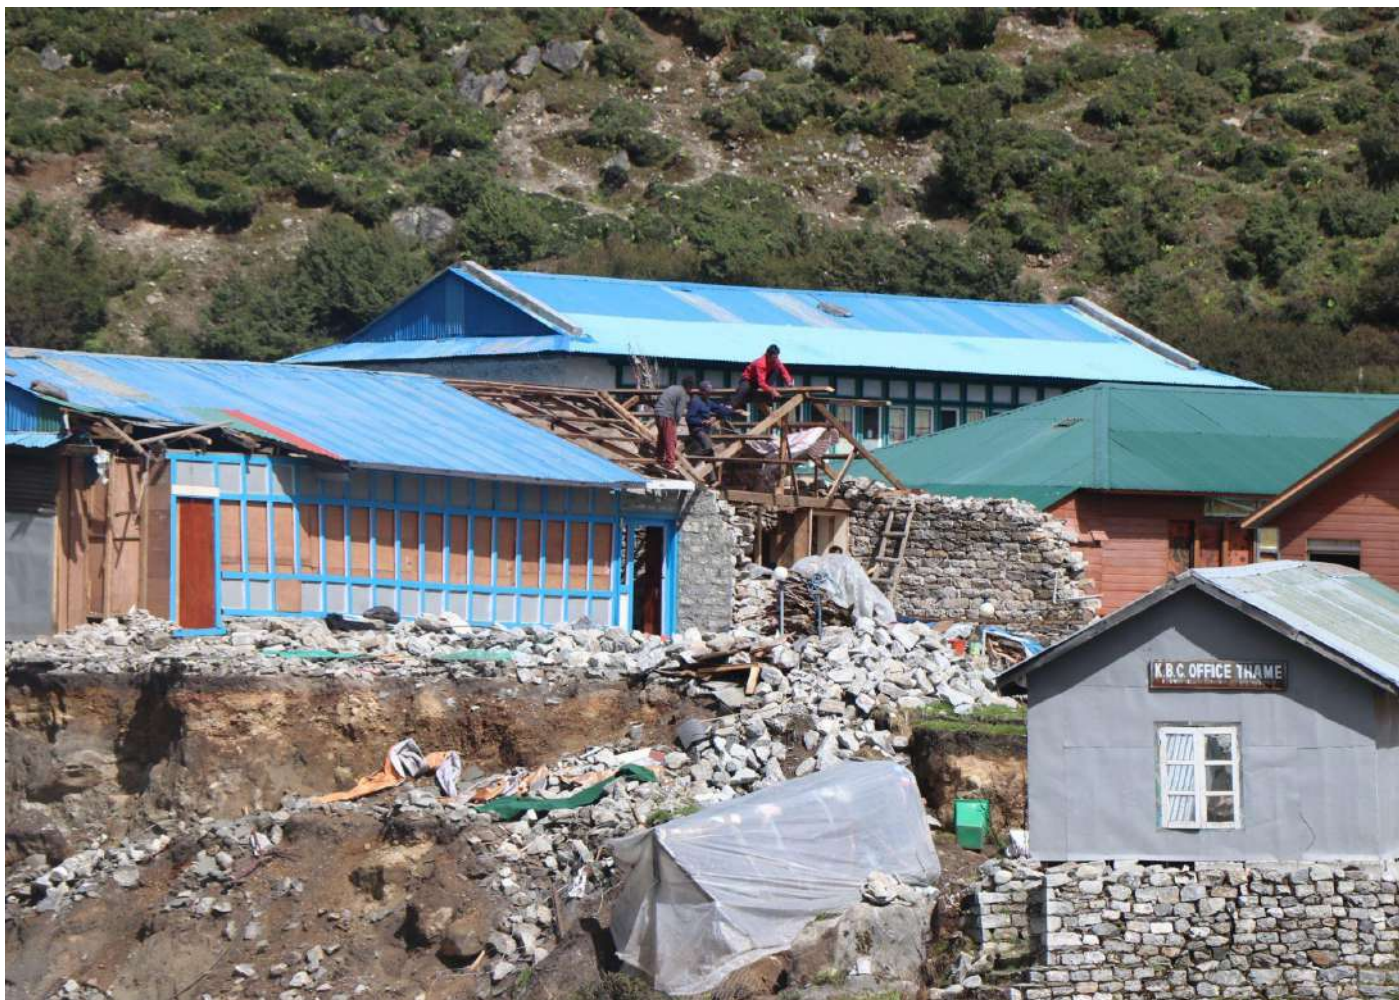
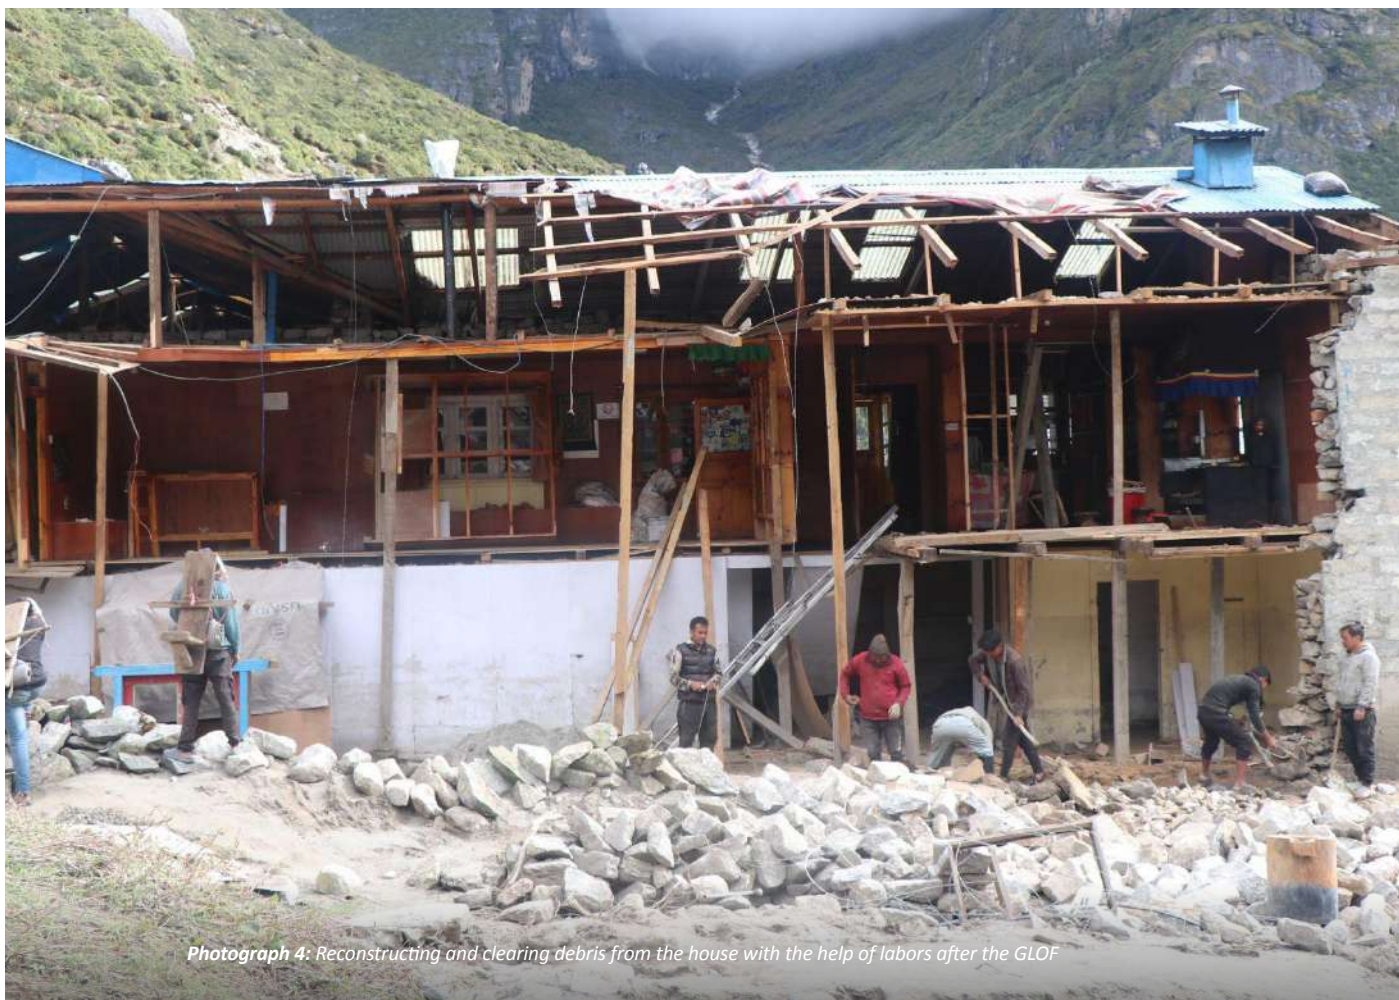
*Photograph 4: Reconstructing and clearing debris from the house with the help of labors after the GLOF*

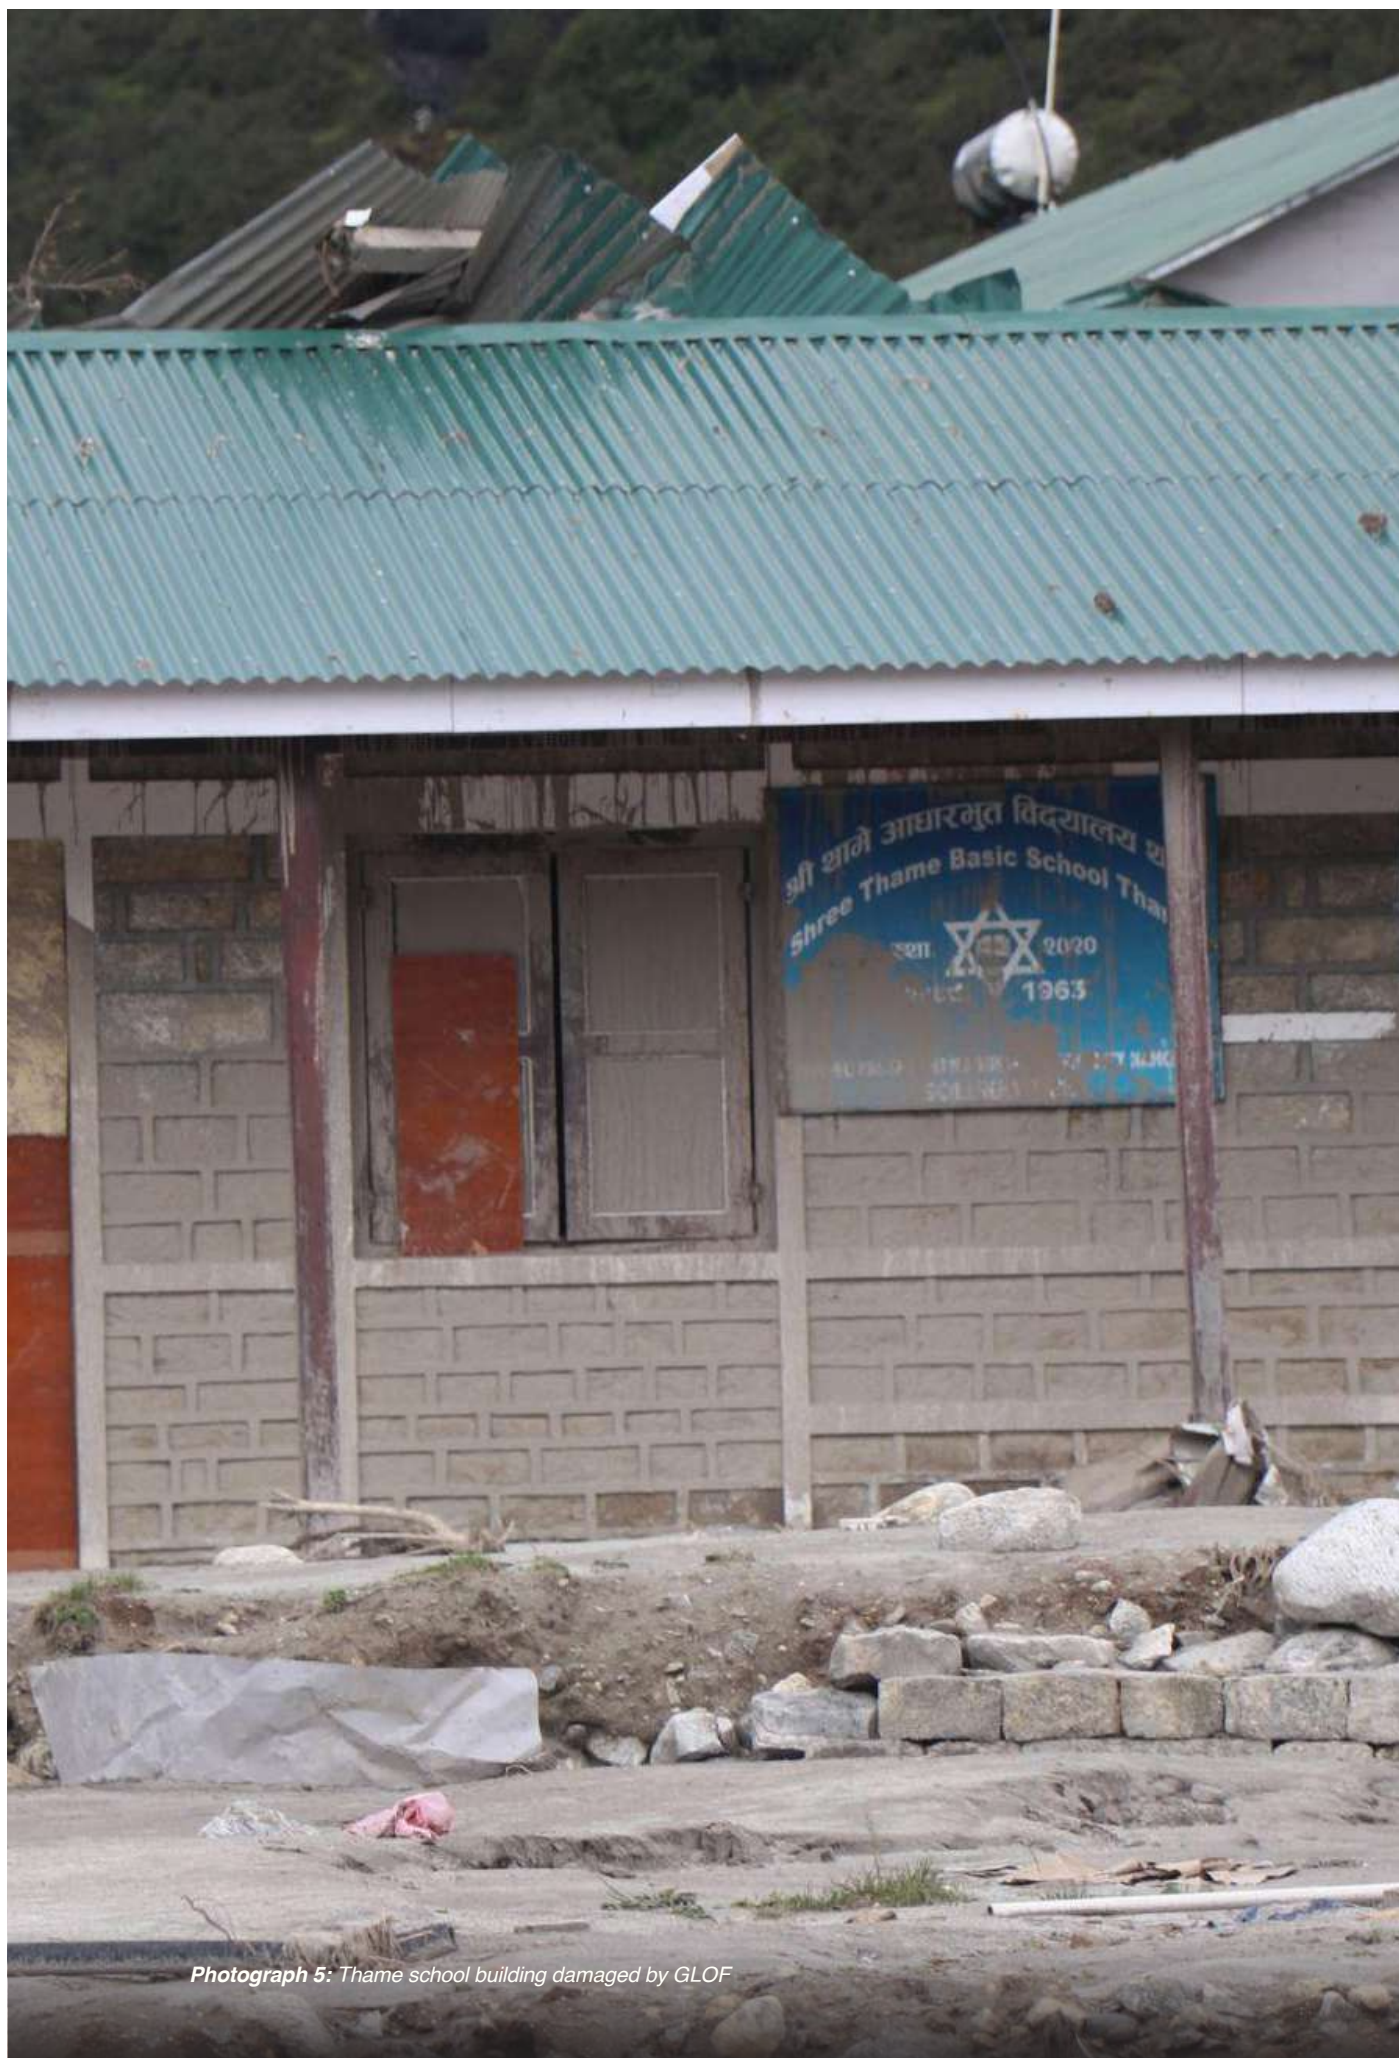
*Photograph 5: Thame school building damaged by GLOF*

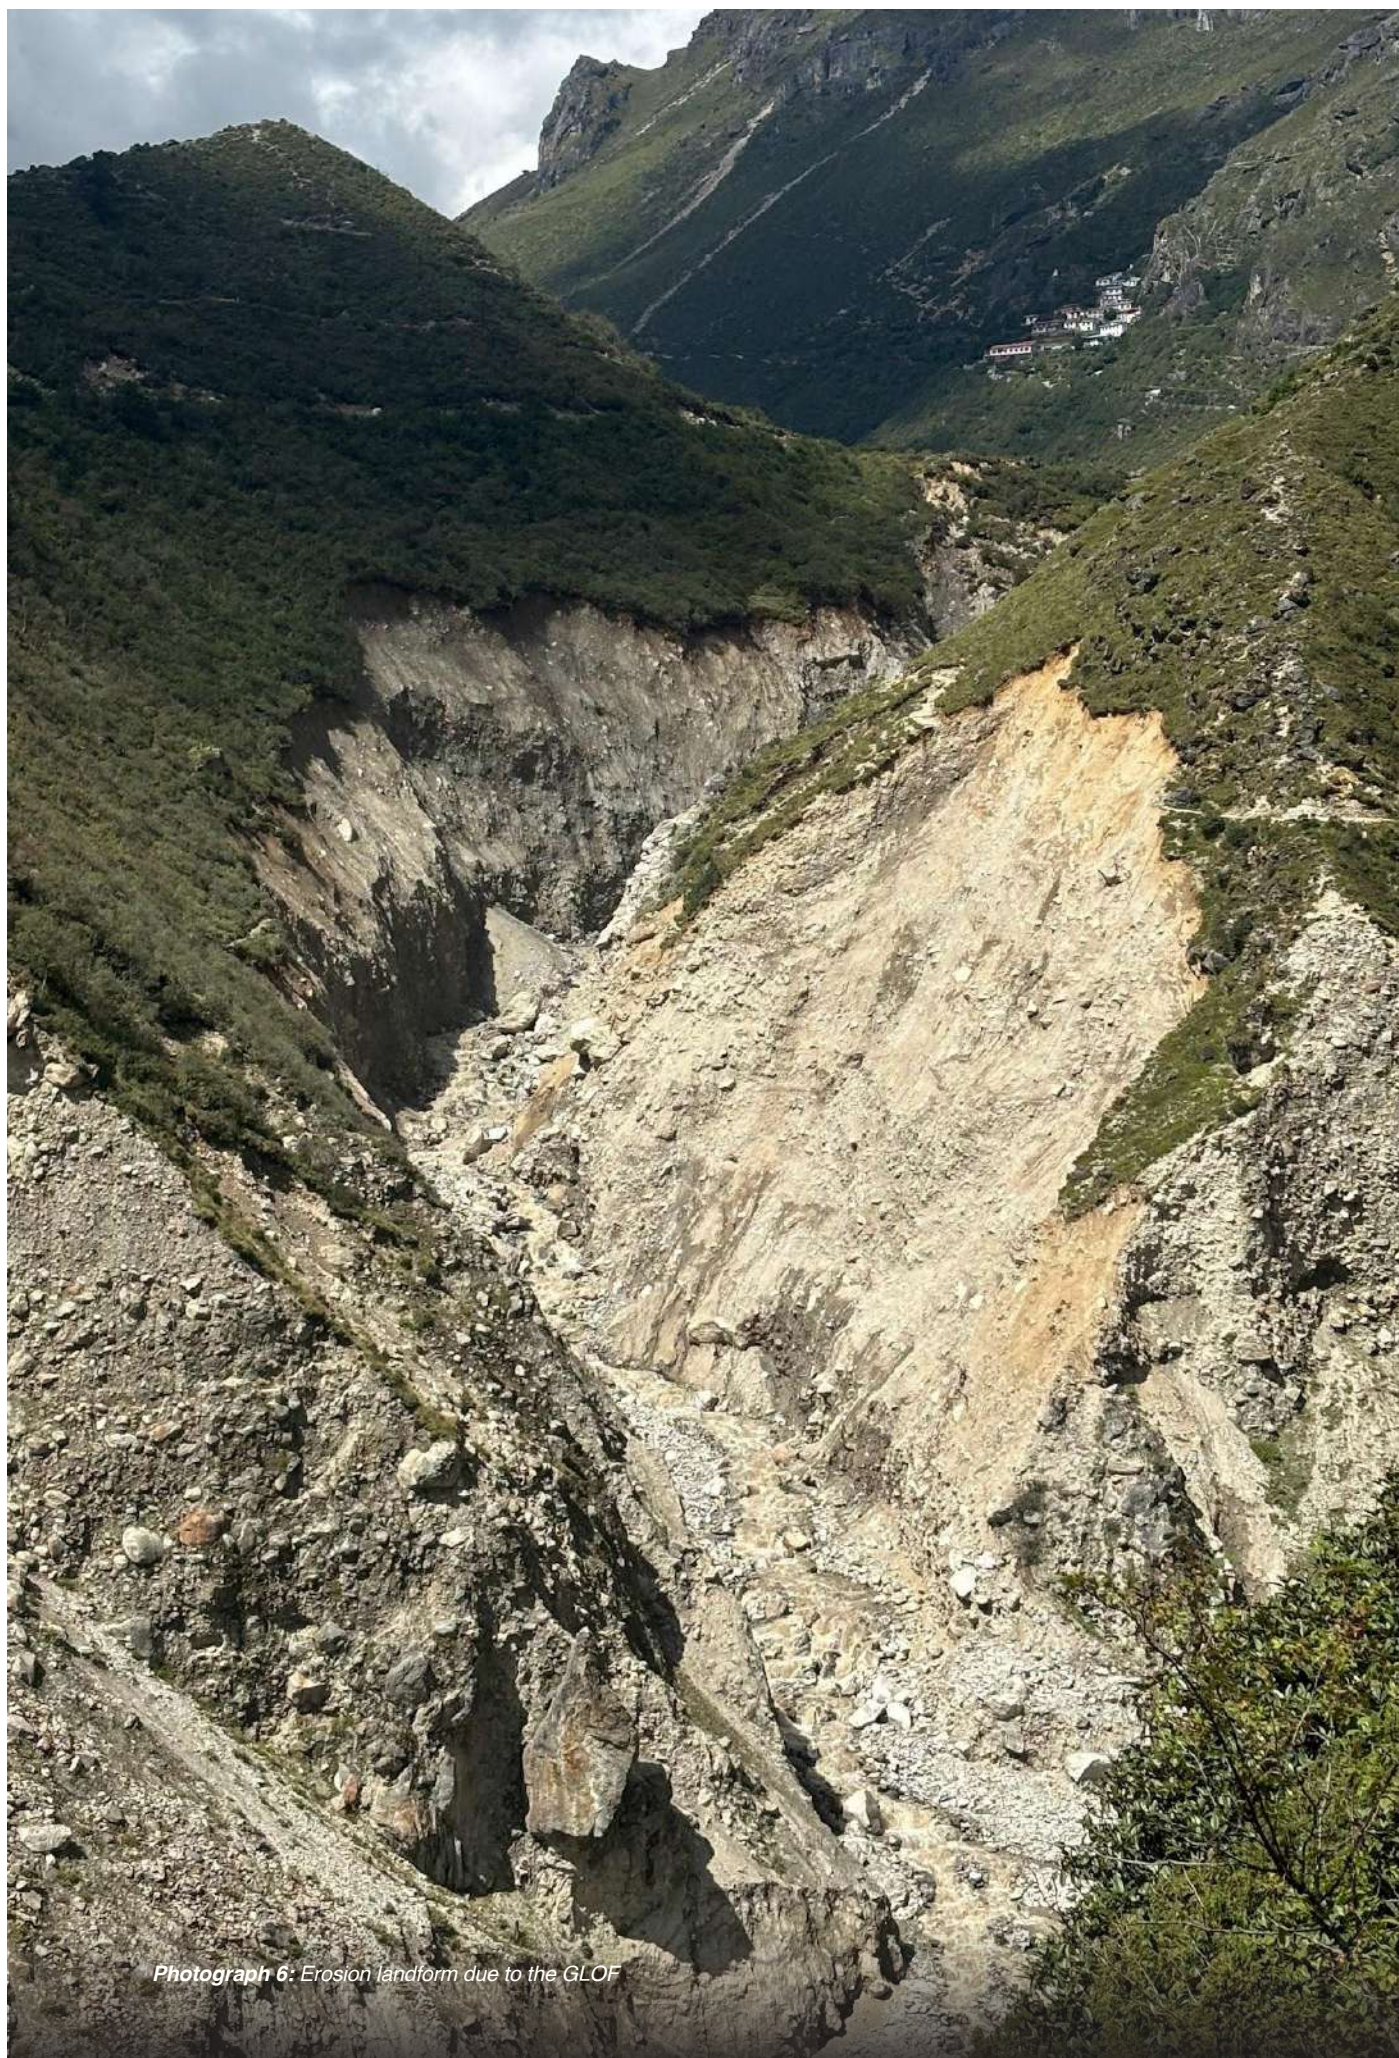
*Photograph 6: Erosion landform due to the GLOF*

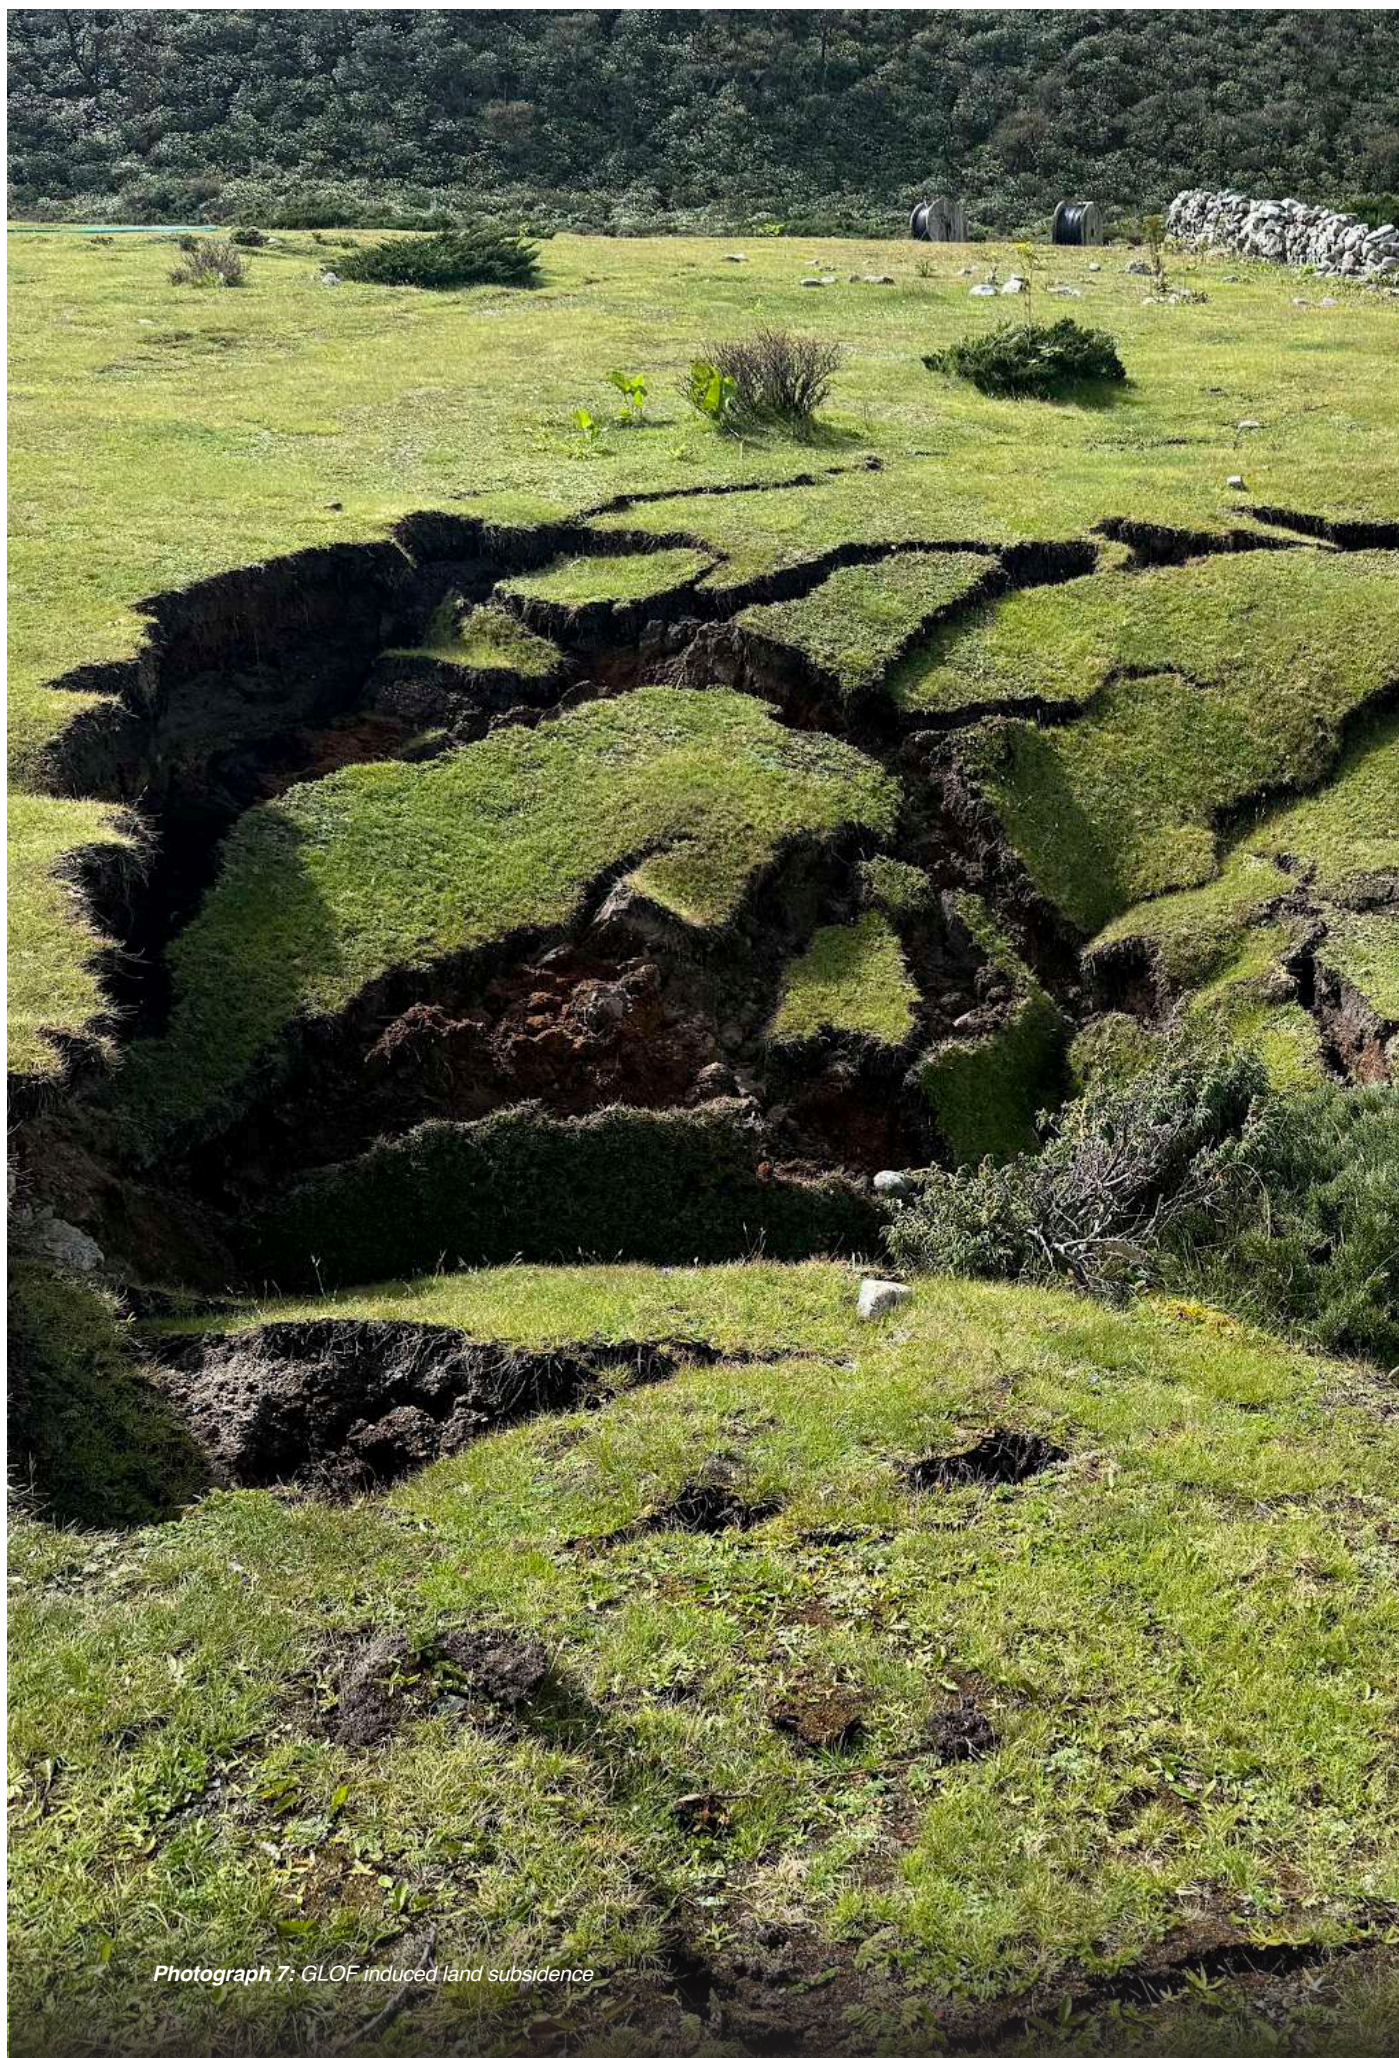
*Photograph 7: GLOF induced land subsidence*

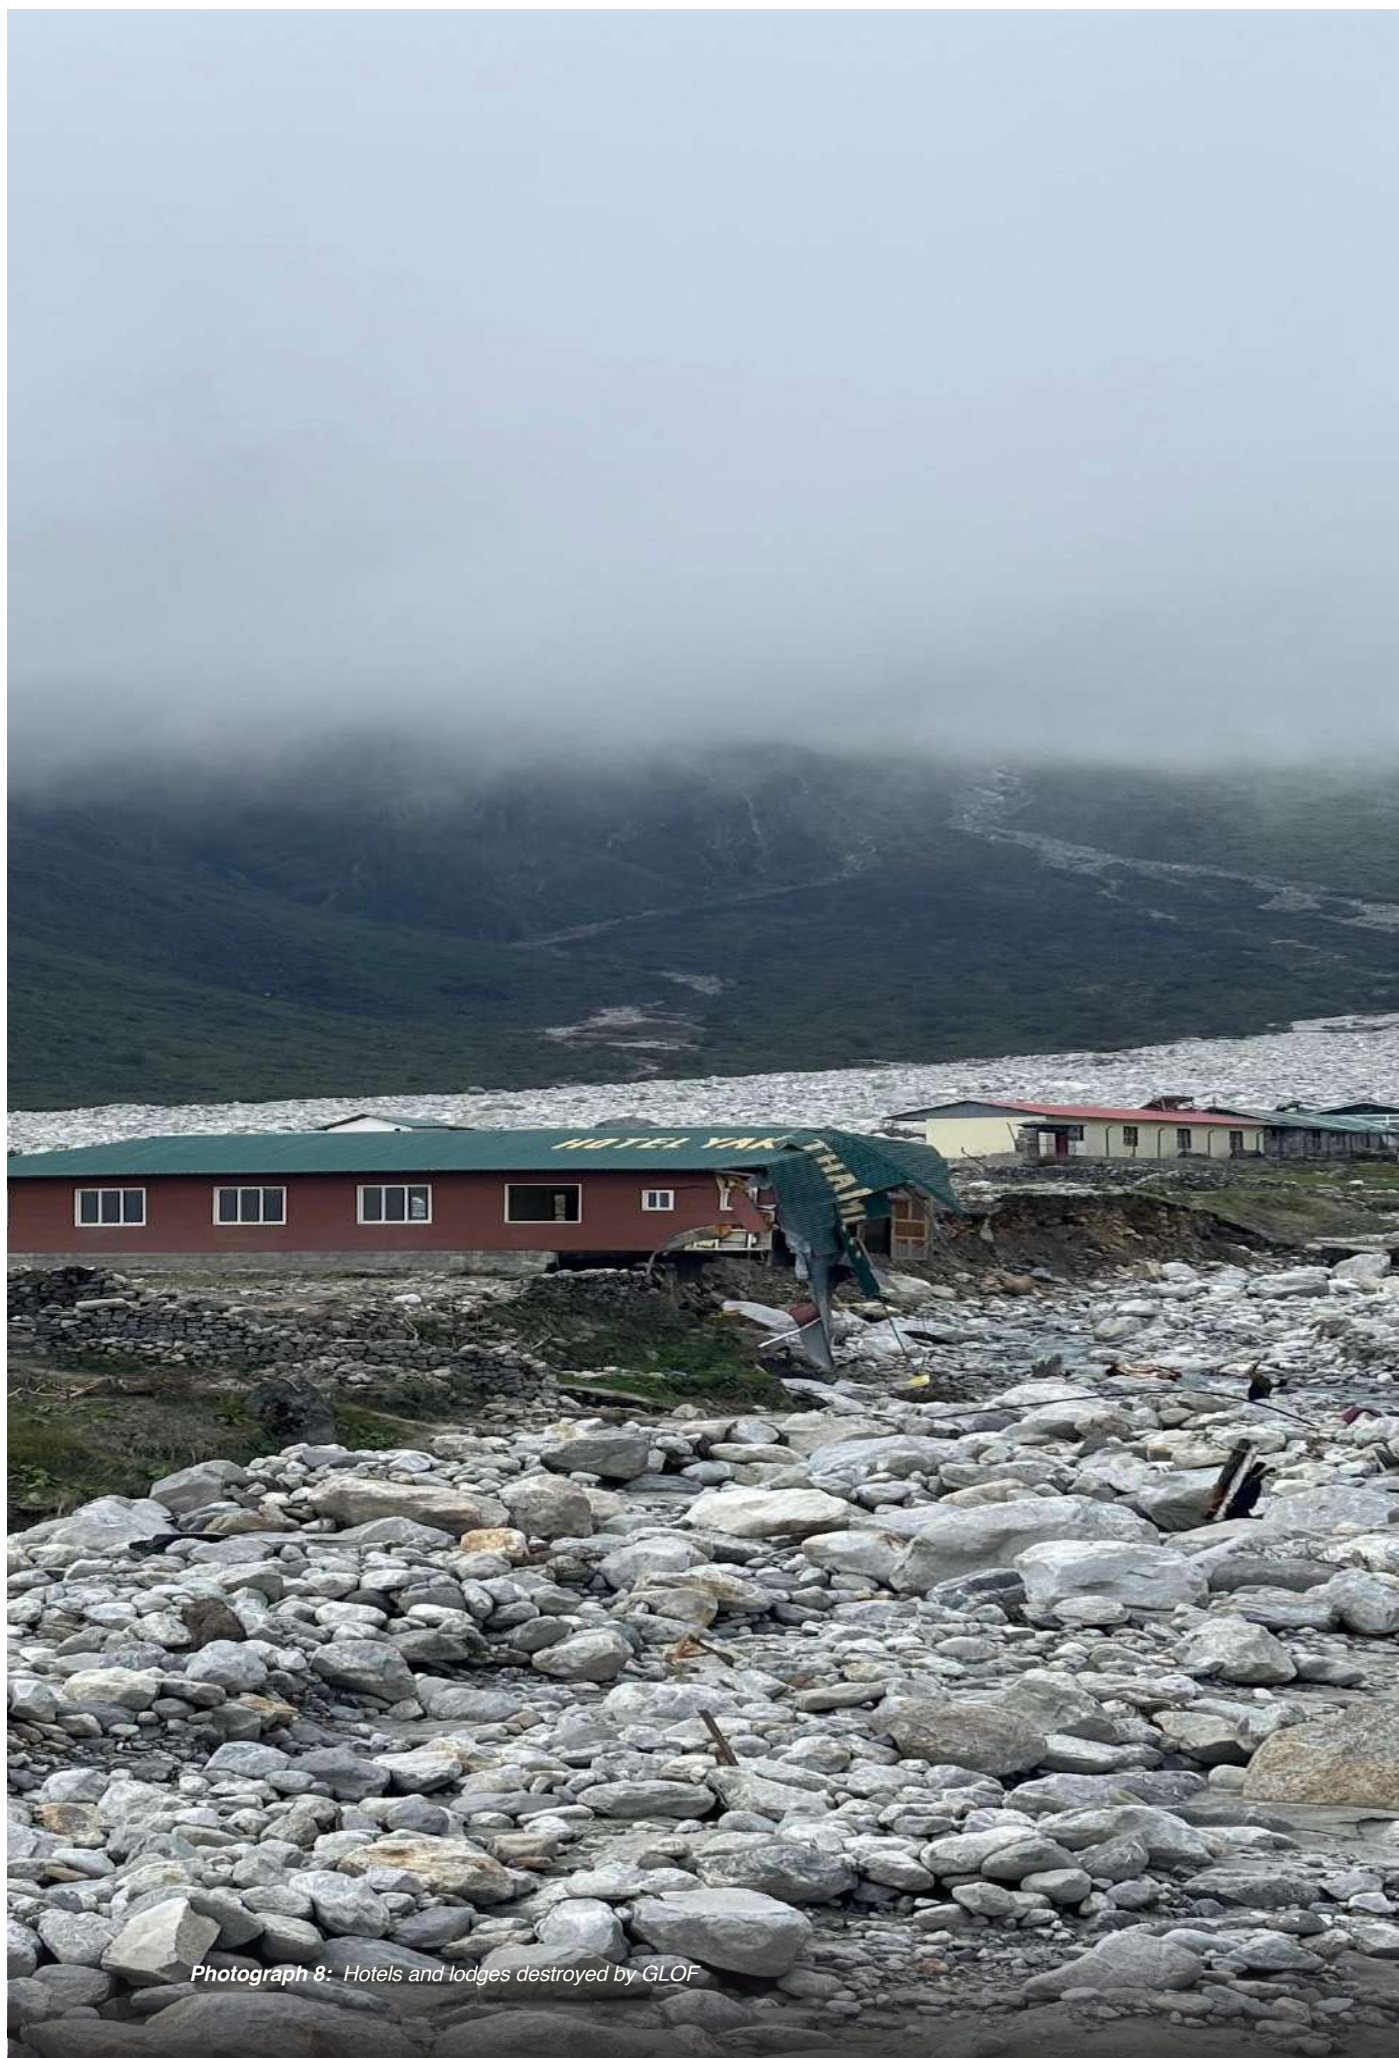
*Photograph 8: Hotels and lodges destroyed by GLOF*
